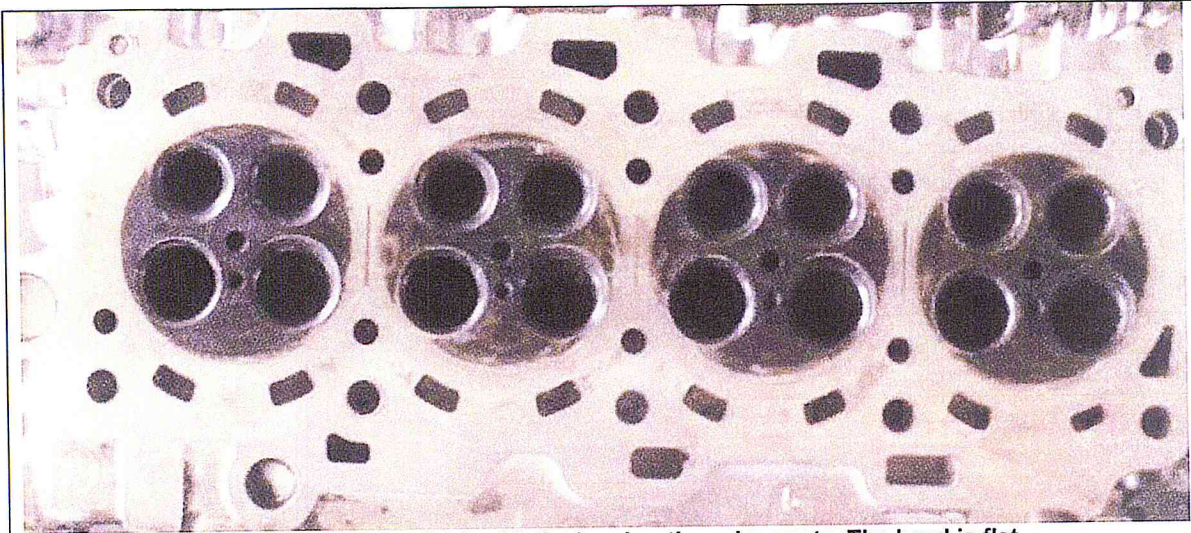
Figure 5: There is no fault with the head or the valve seats. The head is flat.

The table shown above and the pictures below clearly show that the engine is not worn and that it did not overheat. There is no damage at all. Furthermore, the writer cannot agree with the allegation that there was no compression. The reasons being that the valves appeared to have seated properly, there is no scuffing or heat seizure on the pistons and rings, and the head and gasket were sealing properly. The ring end gaps are also confirmation that they were sealing properly.

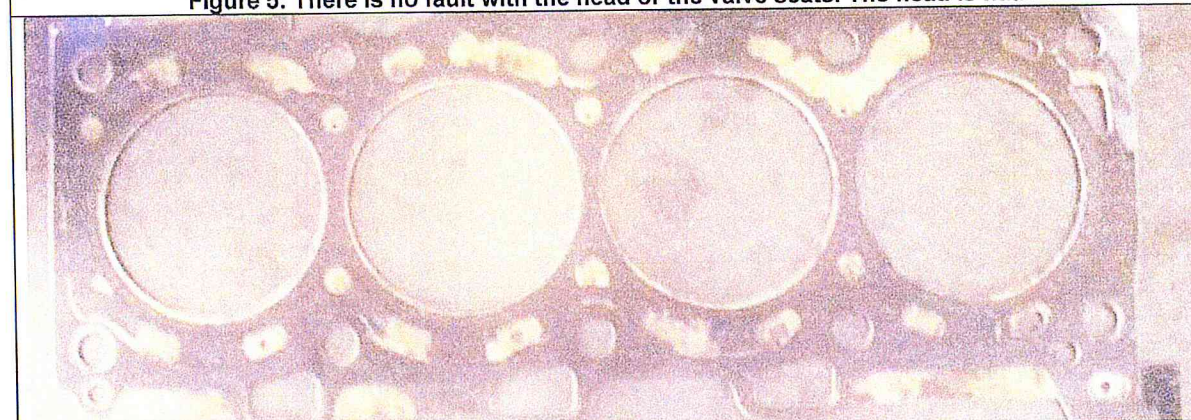
Figure 6: The gasket is not blown

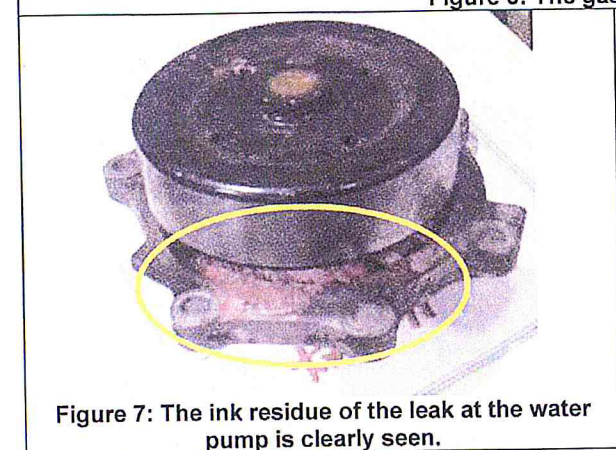
Figure 7: The ink residue of the leak at the water pump is clearly seen.

The water pump did have a leak but this did not result in the engine overheating and being damaged.

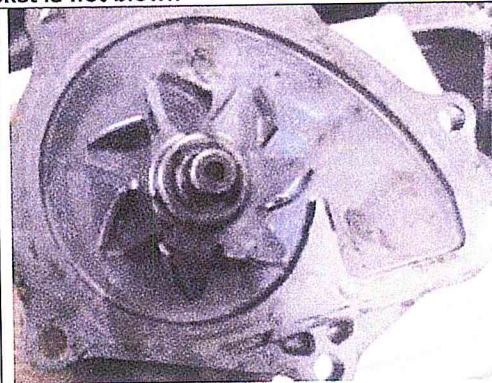
Figure 8: There is no fault in the water pump.

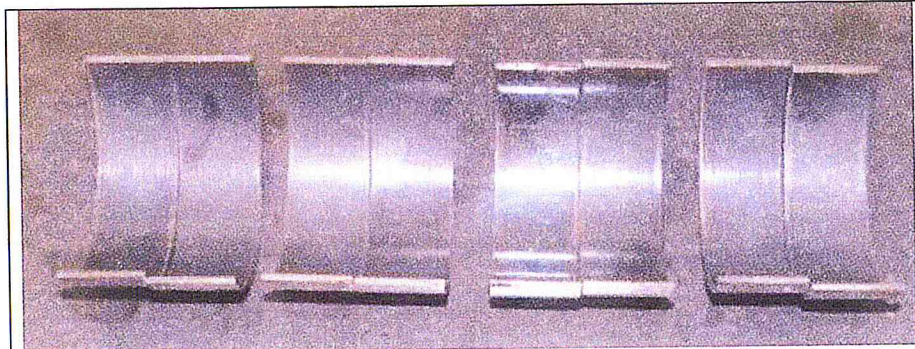
**Figure 9: The bearings do not show any sign of oil starvation. There is some wear and tear however.**
